CONSTRUCTION WIRING INSTALLED IN CONCRETE SLABS

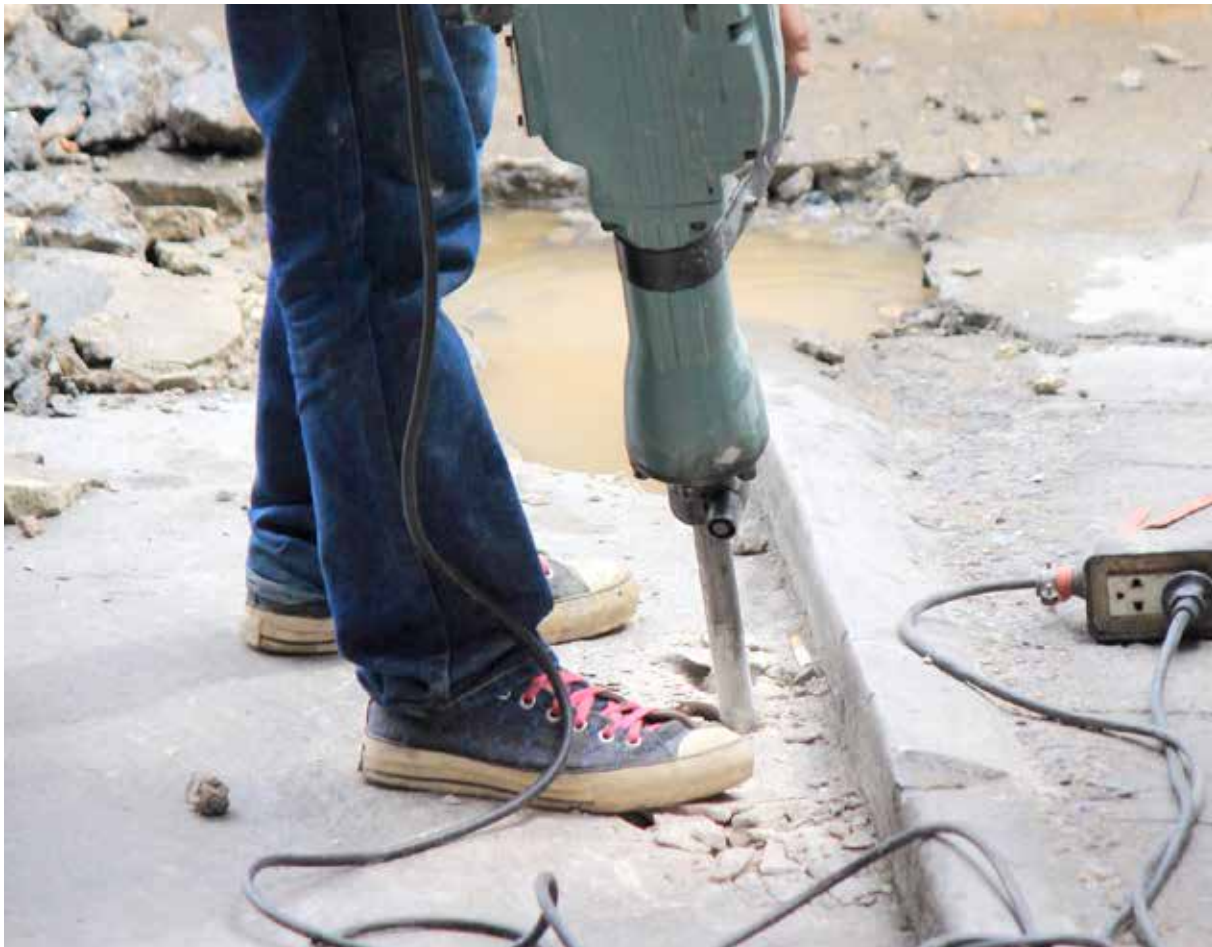
The ETU has been advised of incidents occurring where construction wiring which has been installed in a concrete slab has been damaged when it has been drilled into or cut when coring.

The concern being that generally, the cable is a sub-main feeding the field switchboard, and this cable does not have RCD protection and will not provide personal protection (30mA) to ensure the safety of workers.

The general principle of the *Industry Standard for Electrical Installations on Construction Sites* is for the cable to be marked every 5 metres.

Since this can't be done as the cable is not visible, the cable route is to be clearly identified by permanent marking by some other method which affords the same level of identification for the life of the installation.
